## **Bethesda Rugby/Bingo Club**

### **Protected Species Survey**

**Bethesda Rugby and Bingo Clubs  
Old Station Yard  
Station Road  
Bethesda  
Gwynedd  
LL57 3NE**

**12<sup>th</sup> August 2015**

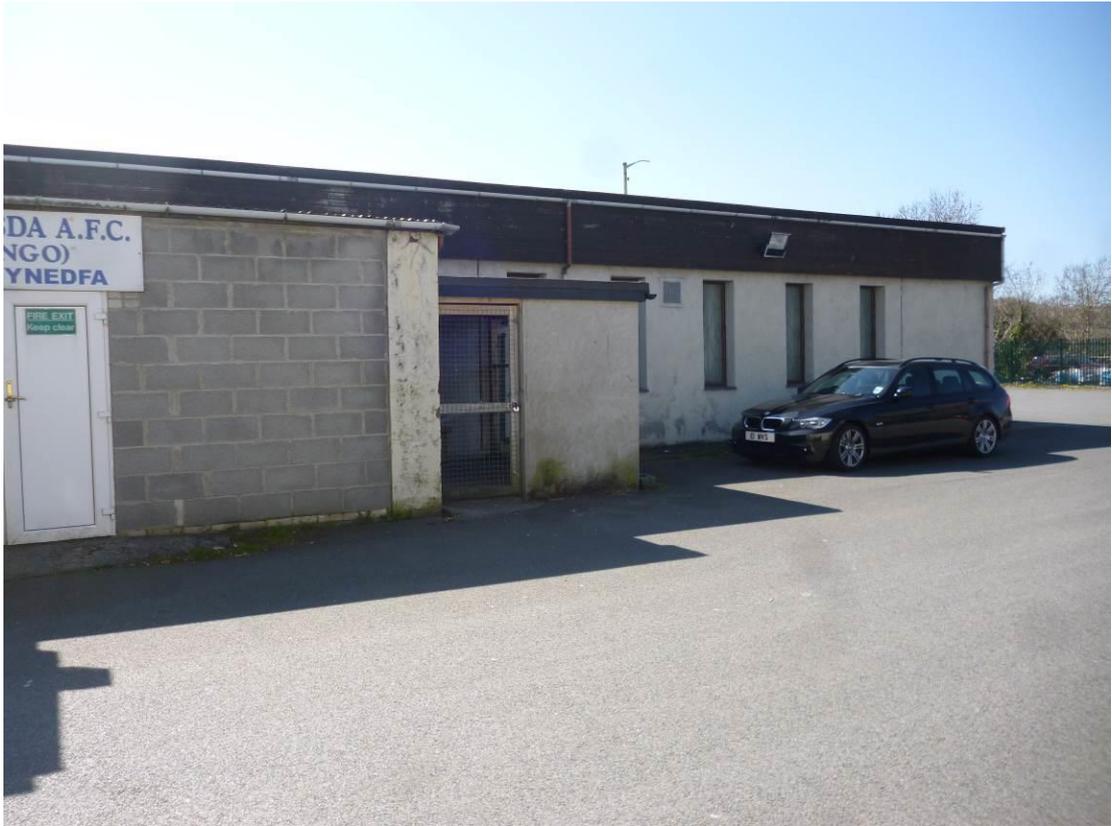
Front elevation (northern end), with potential bat roosting areas behind timber fascias

Although there is no confirmed bat roost within the building on this site, there is the presence of some roosting potential behind exterior timber cladding. For this reason, reasonable avoidance measures are recommended to ensure that there is no inadvertent breach of legislation.

- The removal of the exterior timberwork on the building will be directly supervised by a licensed bat worker
- A single emergence survey will be undertaken prior to the demolition if no works commence within a two year period of this survey.
- All contractors will be made aware of the potential presence of bats and the legal issues involved via a site induction prior to the commencement of works.

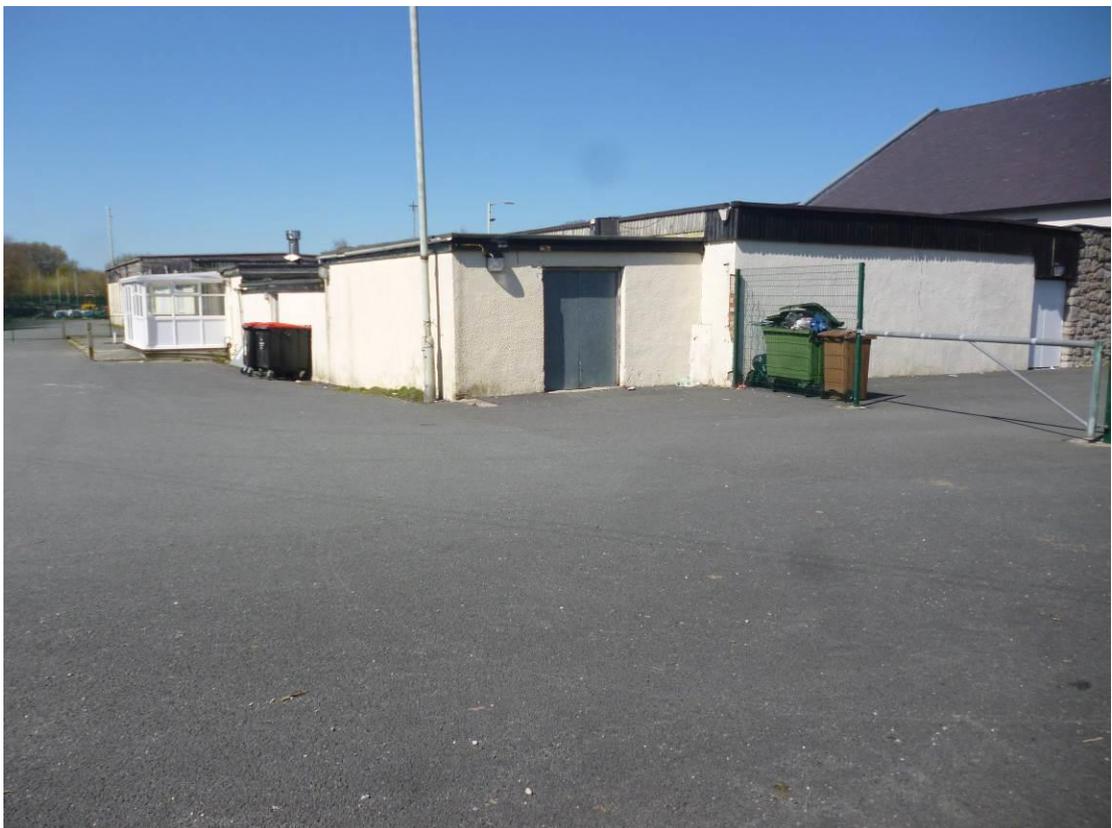
Southern, rear sections, with more bat potential behind fascias

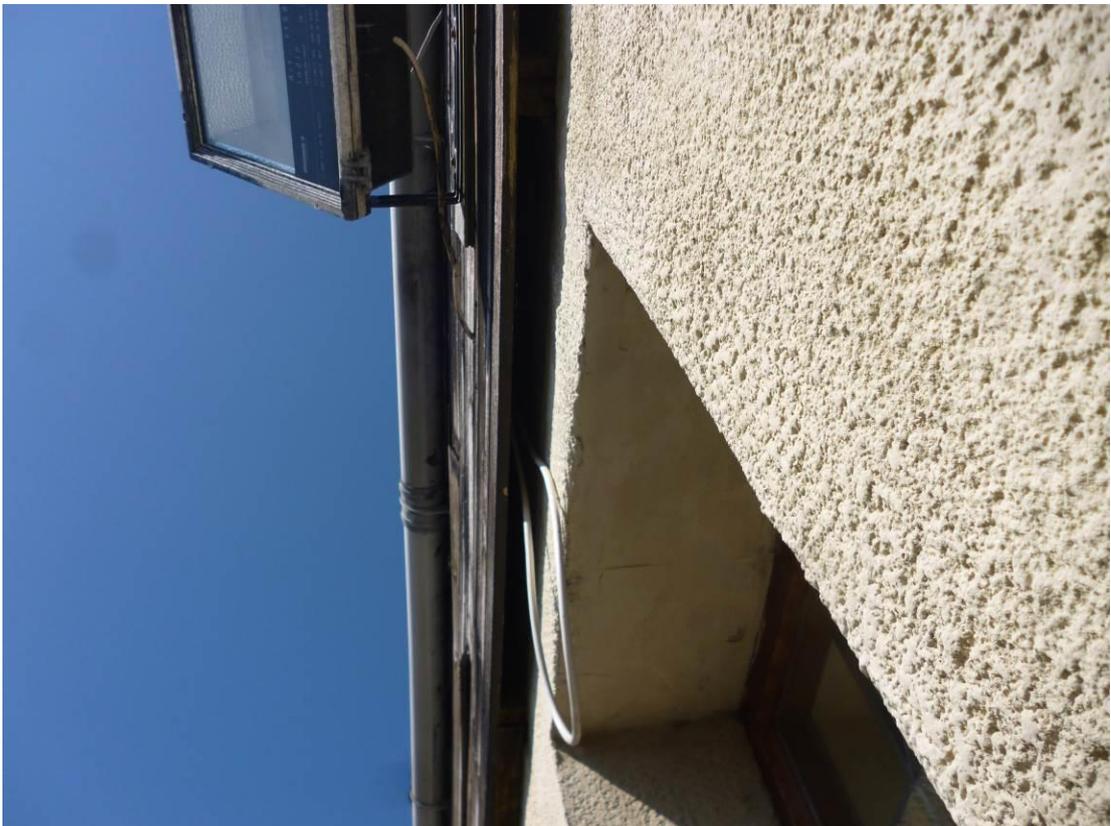
The exterior is a series of flat roof sections, with mainly rendered walls. There are a few walls which are covered with stone cladding or are unrendered breeze block, but there are few cracks and crevices in any of the walls. Some sections have large timber-cladded boarding on the top part of the walls and other sections have well sealed, small fascia boards. The timber cladding has a few sections with missing boards and/or gaps along the bottom edge, giving potential bat access.

Example of the gap behind fascias

Any removal of the exterior timber cladding will be undertaken under the direct supervision of a licensed bat worker in order to minimise the chance of any direct disturbance to the animals themselves and adhere to all current legislation relevant to the species. If the demolition is not undertaken within a two year period from the time of this survey, a single emergence survey will be undertaken to refresh the survey results.
